DAM SAFETY INSPECTION REPORT

Upper Girard Lake Dam

File Number: 1105-001

Inspection Date: May 4, 2016

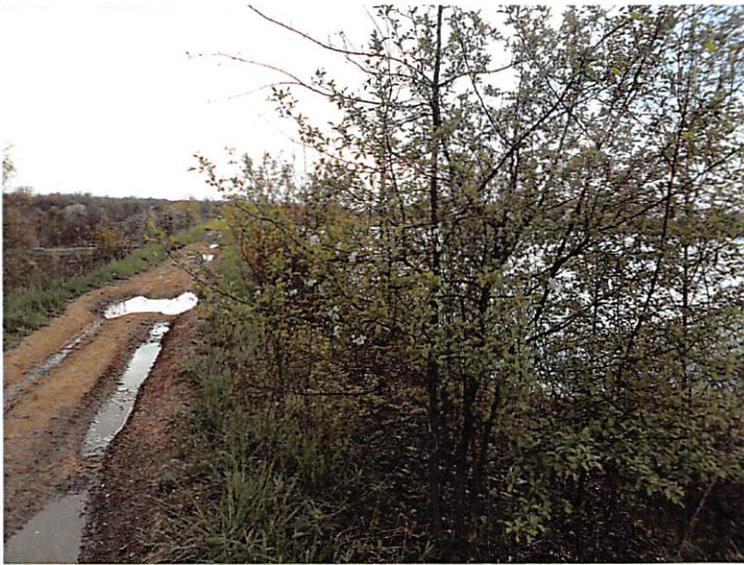
Photograph No. 1:

View of the upstream slope and crest at the far left end of the dam. Note the heavy growth of trees and brush, and the deep rutting on the crest.

5. Repair the deep ruts on the crest and downstream slope at the left end of the south embankment. See the “Ground Cover” fact sheet included in this section for additional information.

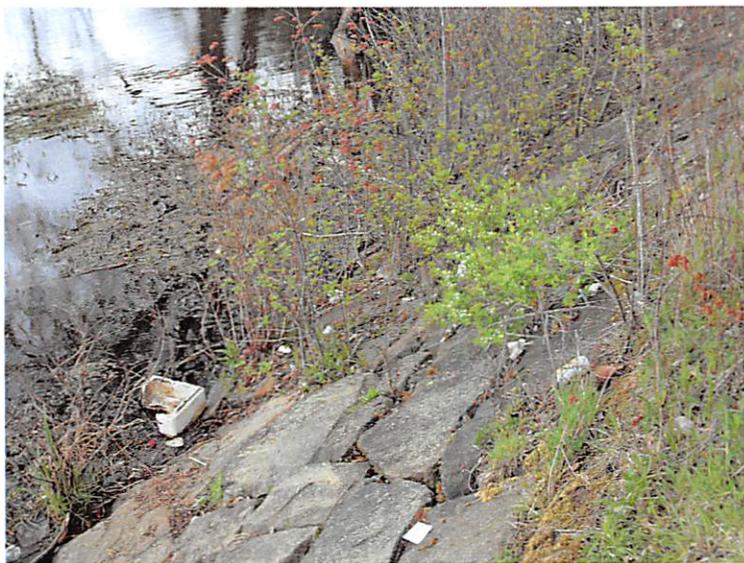
Photograph No. 2:

View of the upstream slope. Note the trees and brush growing up through the slope protection.

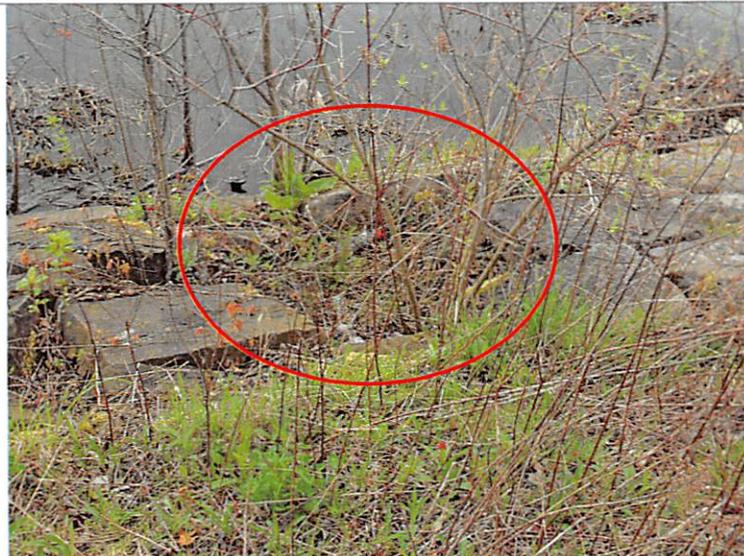
Photograph No. 3:

View of an area where the slope protection has become displaced.

3. Repair the displaced slope protection on the upstream slope. See the “Upstream Slope Protection” fact sheet included in this section for additional information.

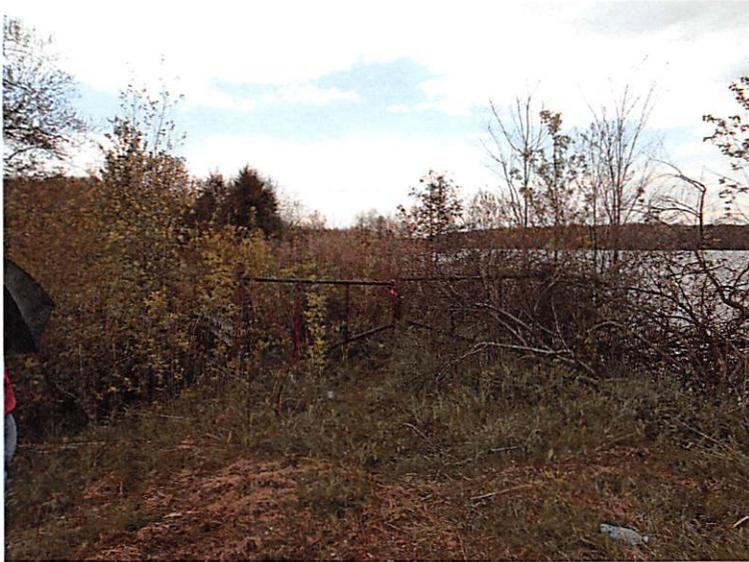
Photograph No. 5:

View of the embankment at the far right end. Note the heavy growth of trees and brush on the entire embankment.

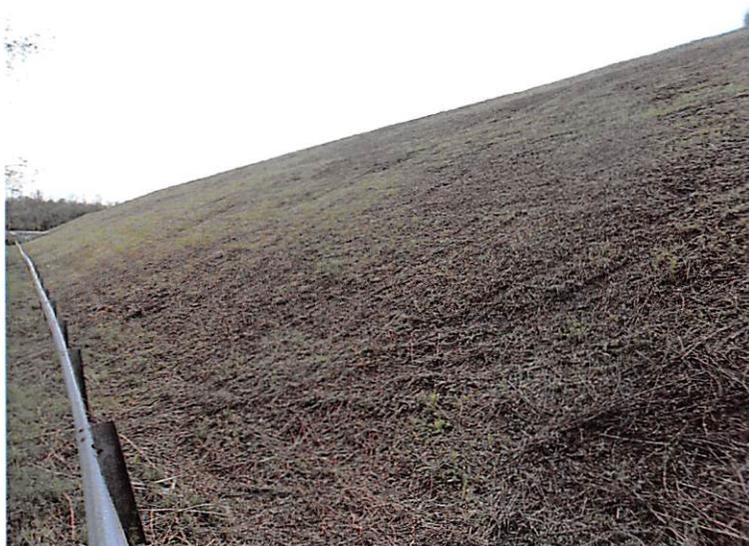
Photograph No. 6:

Overview of the area on the downstream slope that had recently been cleared. You can see that the slope is sparsely covered in grass.

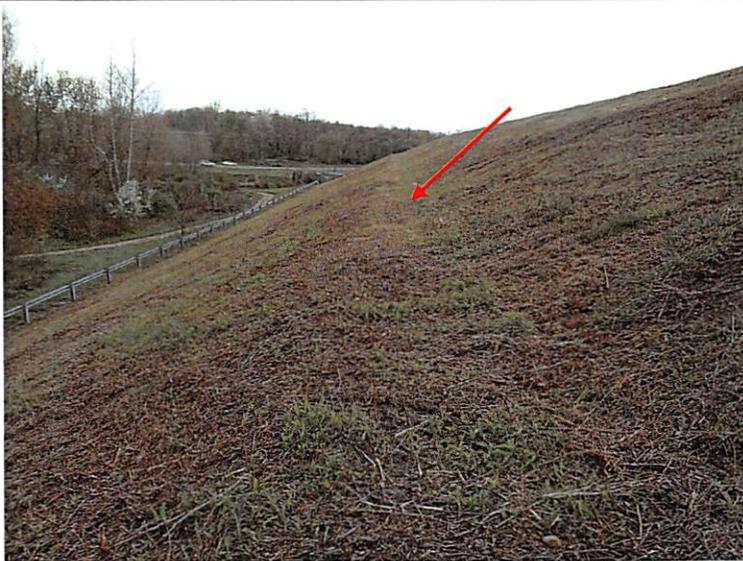
Photograph No. 8:

Note that there is a slight bench constructed in the downstream slope. This bench is present on the south embankment and part of the south west embankment. It is not believed that a bench is on the west embankment, but heavy trees and brush prohibited a proper inspection.

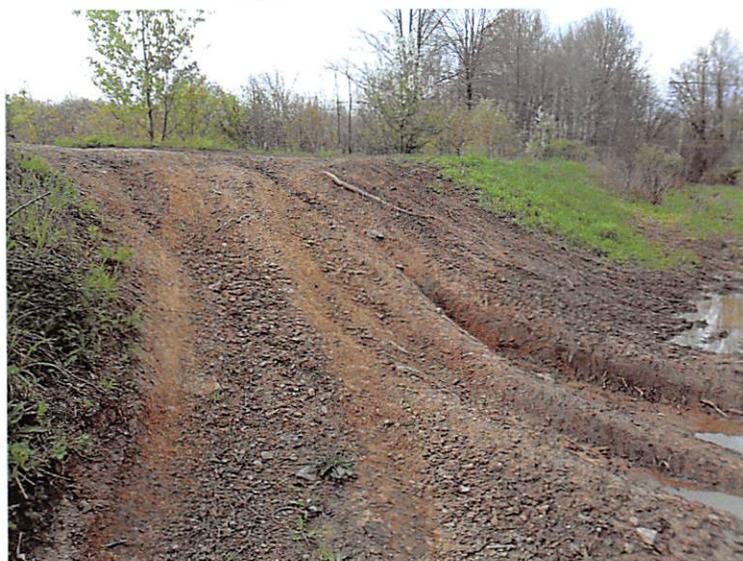
Photograph No. 9:

View of the far left end of the downstream slope. ATV riders have carved roads on the slope and left them rutted and bare of vegetation.

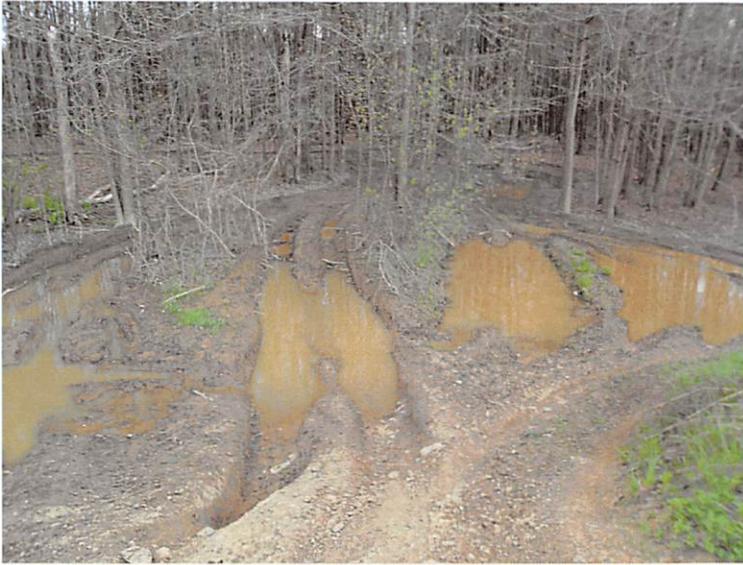
Photograph No. 10:

Immediately below the road you can see the rutting and ponded water. This area may be where seepage was noted in a previous inspection report.

1. Once the ruts have been repaired on the crest and downstream slope at the far left end of the south embankment, monitor the area quarterly for any reoccurrence of a wet area. See the "Seepage Through Earthen Dams" fact sheet included in this section for guidance in monitoring for seepage and for additional information.

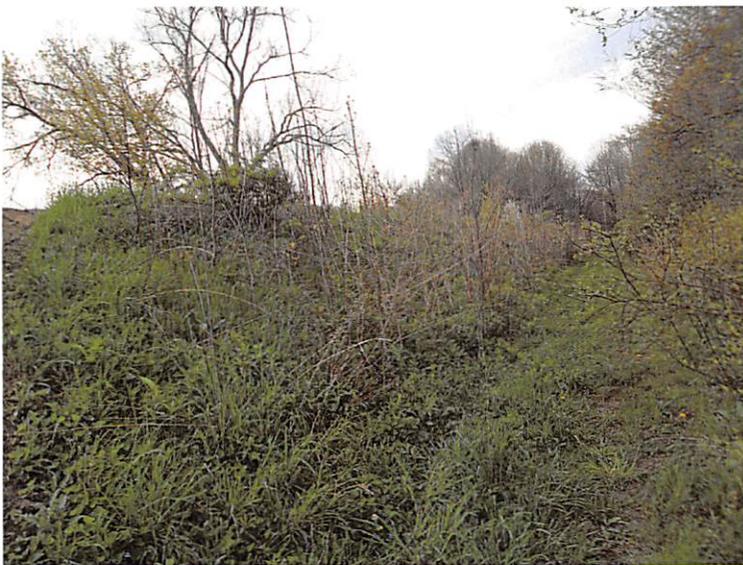
Photograph No. 11:

Far left end of the downstream slope. Note the trees and brush.

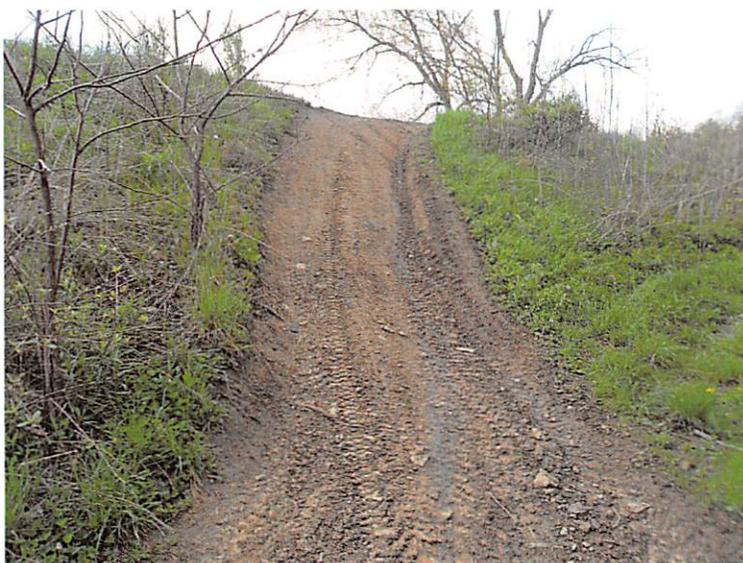
Photograph No. 12:

View of the far left end of the downstream slope. ATV riders have carved roads on the slope and left them rutted and bare of vegetation.

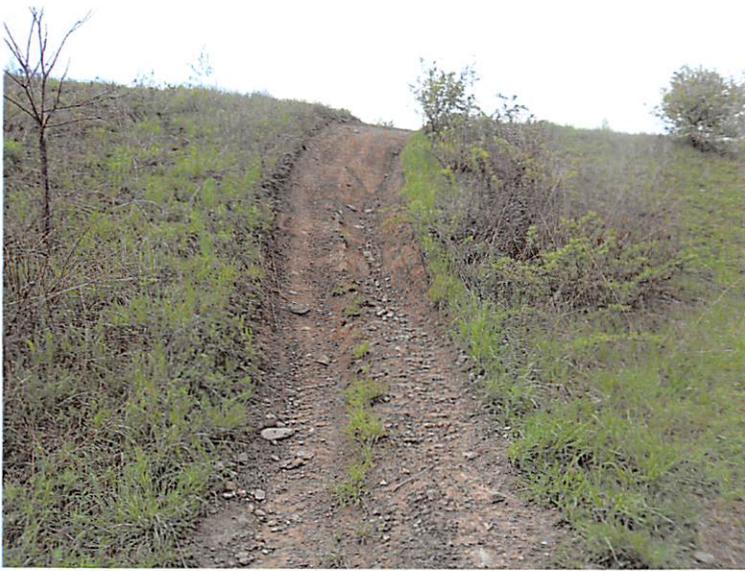
Photograph No. 13:

View of the far left end of the downstream slope. ATV riders have carved roads on the slope and left them rutted and bare of vegetation.

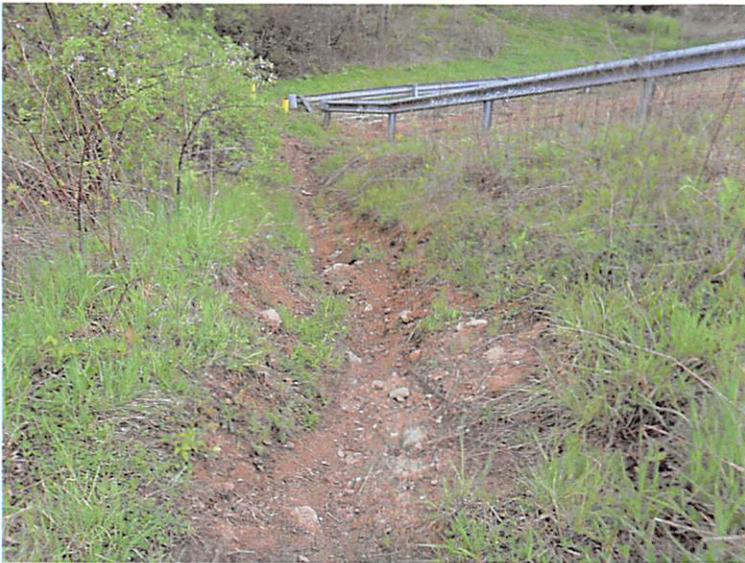
Photograph No. 14:

A deep erosion gully had developed at the lower downstream groin near the left end of the dam.

4. Repair the erosion gully on the left groin of the downstream slope of the south embankment. See the “Ground Cover” fact sheet included in this section for additional information.

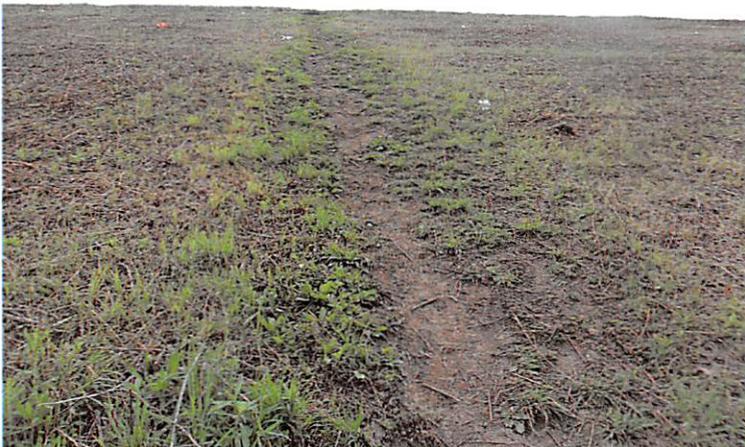
Photograph No. 15:

A bare foot path was located on the slope directly above the principal spillway outlet pipe. Again, note the sparse grass cover on the slope.

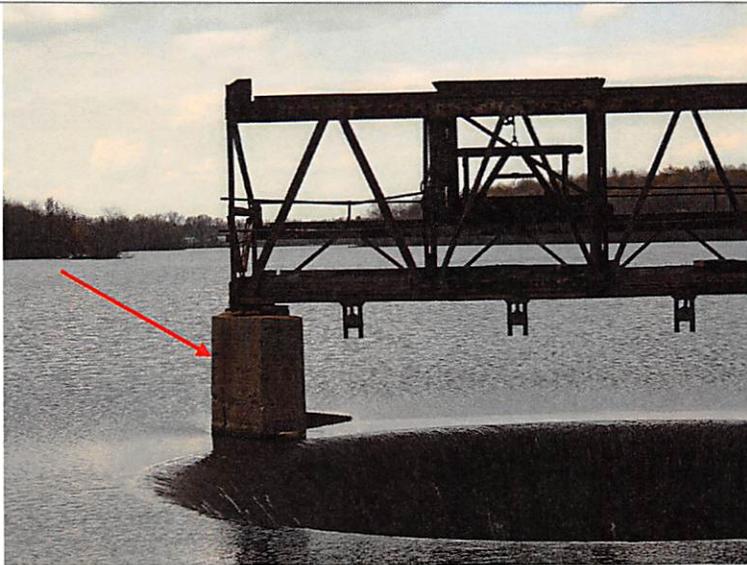
Photograph No. 17:

View of the lake drain structure abutment. The arrow points to where the staff gage was adhered to at the last inspection.

7. Replace the staff gauge that was located on the lake drain inlet structure. Please note that the graduations should extend below the normal pool level to allow monitoring during drawdowns. See Discussion Item D included in this section for additional information.

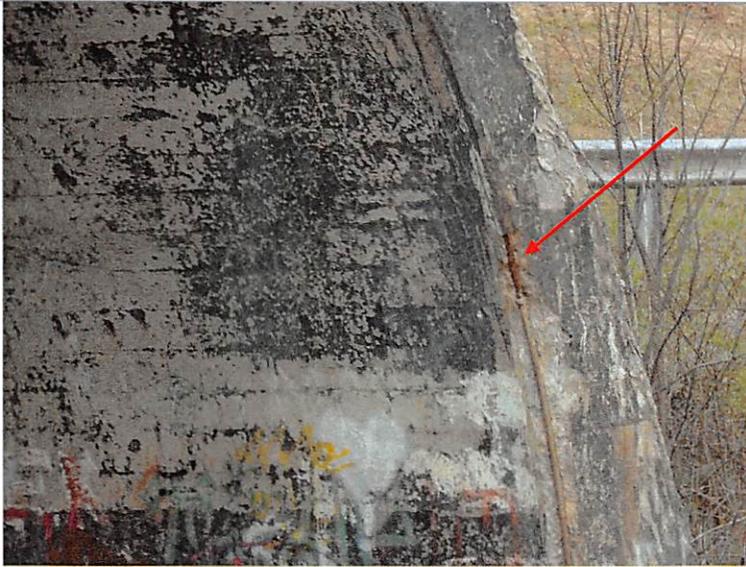
Photograph No. 19:

View of some exposed rebar in the principal spillway outlet pipe.

5. The discharge tunnel must be repaired. Prepare plans and specifications for the repair of all spalling on the interior and exposed exterior portions of the principal spillway outlet pipe and for resealing the spillway joints. Monitor the joints in the principal spillway discharge tunnel quarterly for loss of sealant until repairs are made. See the "Spillway Conduit System Problems" and "Problems with Concrete Materials" fact sheets included in this section for additional information.

6. Repair the deterioration on the principal spillway discharge tunnel. See the “Spillway Conduit System Problems” and “Concrete Repair Techniques” fact sheets included in this section for additional information.

2. Until repairs can be made, monitor the deterioration of the principal spillway discharge tunnel quarterly for further deterioration. See the "Spillway Conduit System Problems", "Concrete Repair Techniques", and "Problems with Concrete Materials" fact sheets included in this section for guidance in monitoring the spillway system and for additional information.

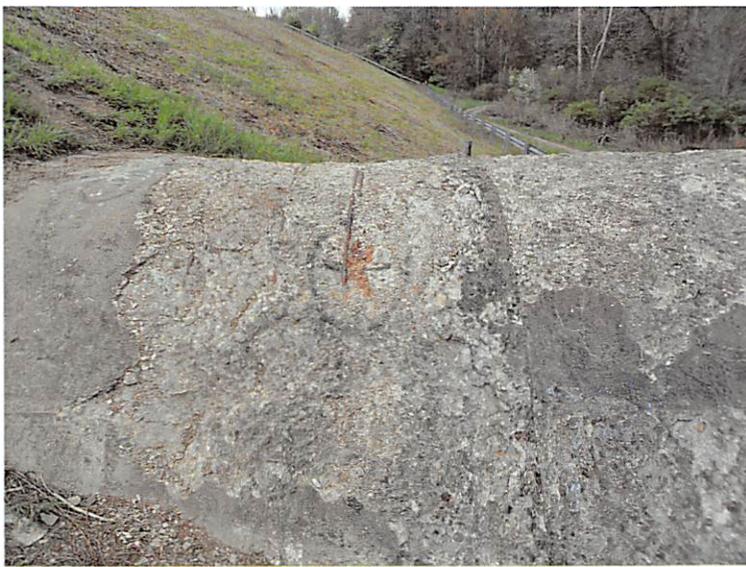
Photograph No. 20:

View of some exposed rebar in the principal spillway outlet pipe.

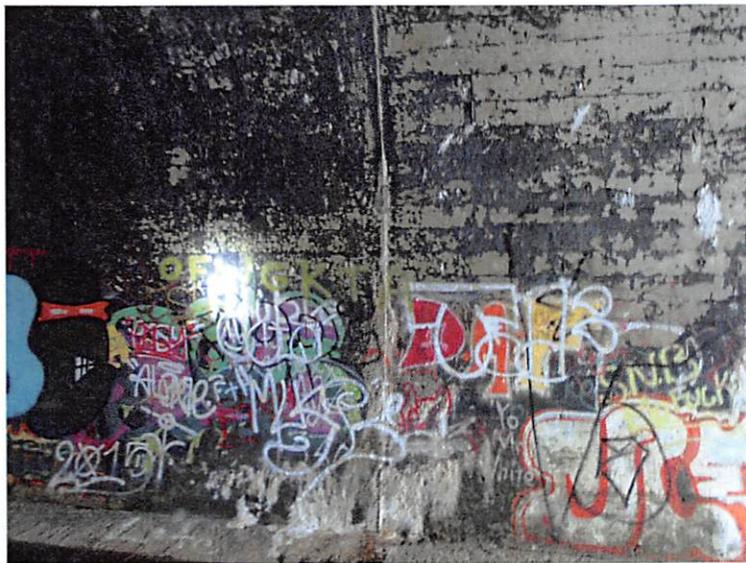
Photograph No. 21:

View of one of the joints in the principal spillway outlet pipe.

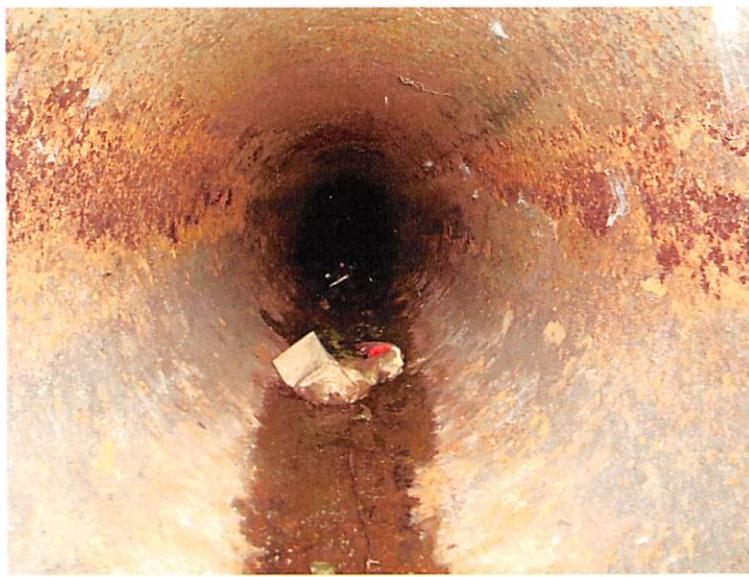
Photograph No. 23:

View inside the lake drain outlet pipe. Note the corrosion of the metal pipe and the litter in the pipe.

3. The lake drain must operate properly and safely. Investigate the integrity of the sluice gates and the outlet pipe. Prepare plans and specifications for the repair of the gates and outlet pipe. See the "Lake Drains" fact sheet included in this section for additional information.

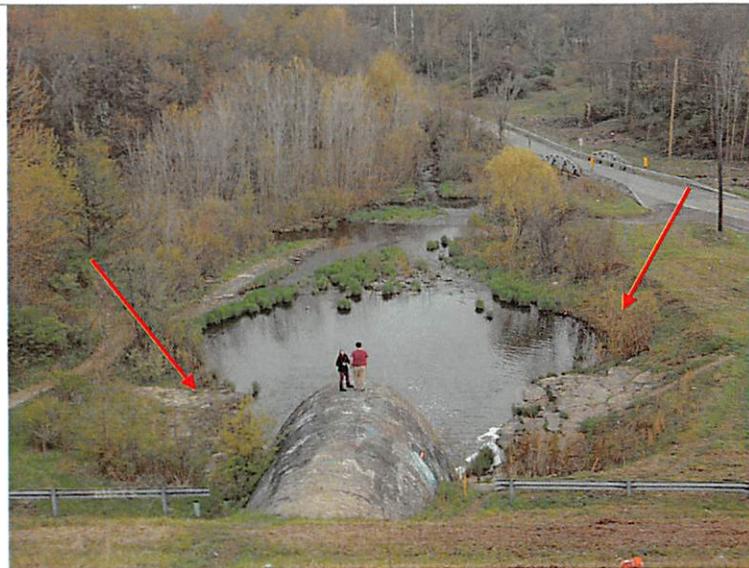
Photograph No. 24:

View of the plunge pool for the principal spillway and lake drain outlets. The arrows point to where heavy discharges had caused new erosion in the plunge pool noted at the last inspection. These areas appear to have stabilized.

3. Monitor the erosion around the sides of the plunge pool quarterly for additional erosion, sloughing, or slope instability. See the "Outlet Erosion Control Structures (Stilling Basins)" fact sheet included in this section for guidance in monitoring the condition of the plunge pool and for additional information.
