DAM SAFETY INSPECTION REPORT

Upper Girard Lake Dam

File Number: 1105-001

Inspection Date: May 4, 2016

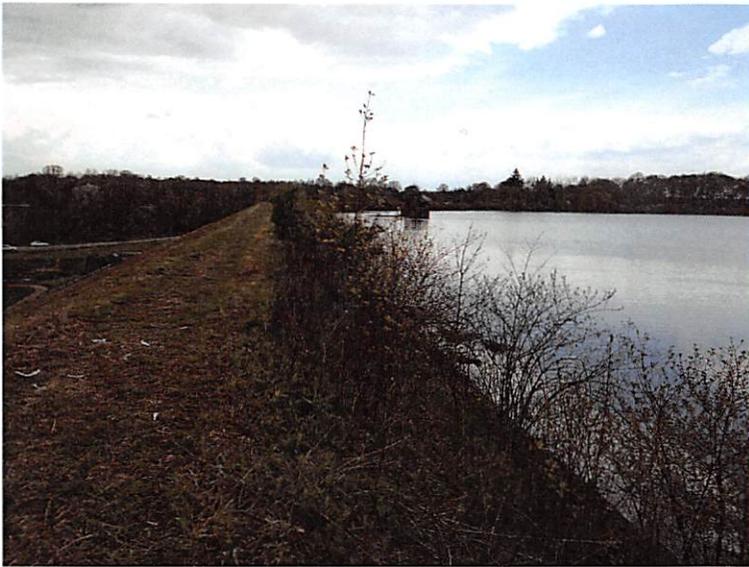
Photograph No. 3:

View of an area where the slope protection has become displaced.

3. Repair the displaced slope protection on the upstream slope. See the “Upstream Slope Protection” fact sheet included in this section for additional information.

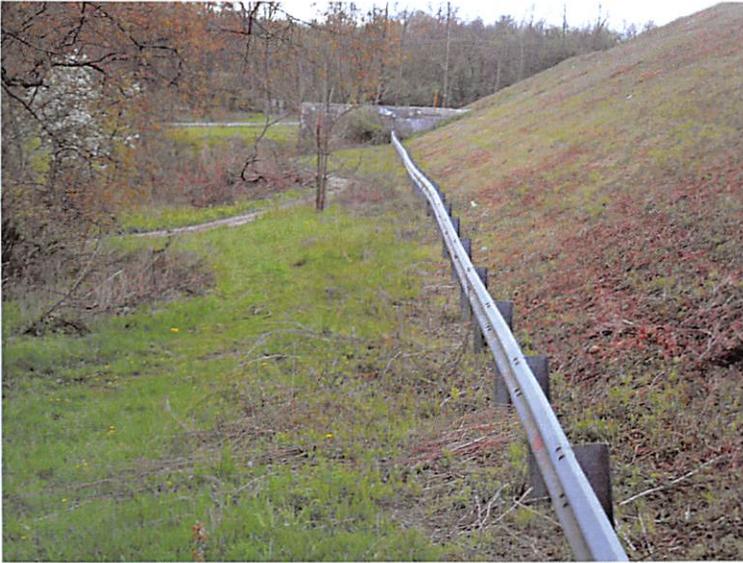
Photograph No. 6:

Overview of the area on the downstream slope that had recently been cleared. You can see that the slope is sparsely covered in grass.

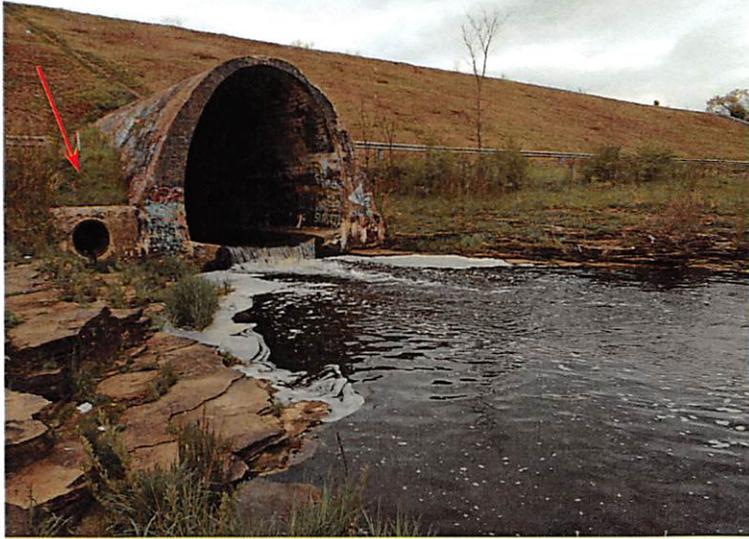
Photograph No. 21:

View of one of the joints in the principal spillway outlet pipe.

5. The discharge tunnel must be repaired. Prepare plans and specifications for the repair of all spalling on the interior and exposed exterior portions of the principal spillway outlet pipe and for resealing the spillway joints. Monitor the joints in the principal spillway discharge tunnel quarterly for loss of sealant until repairs are made. See the "Spillway Conduit System Problems" and "Problems with Concrete Materials" fact sheets included in this section for additional information.
